Agitator Prop Repair

Ekato Agitator Modules

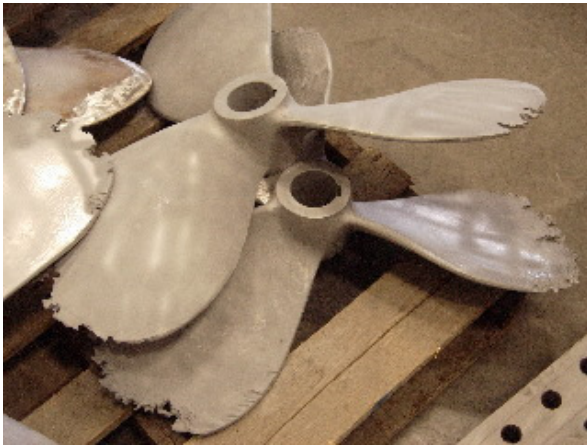
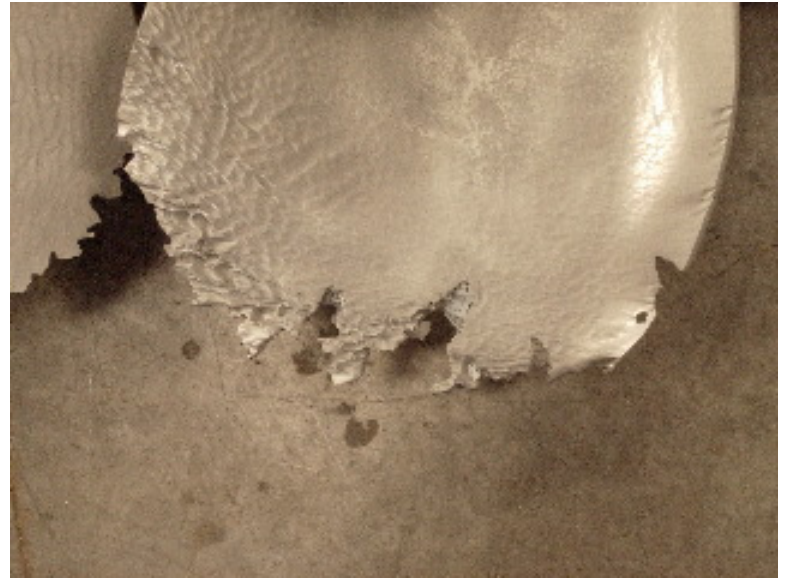
Before

Prop blades were suffering from premature failure due to the harsh abrasive environment in agitator modules.

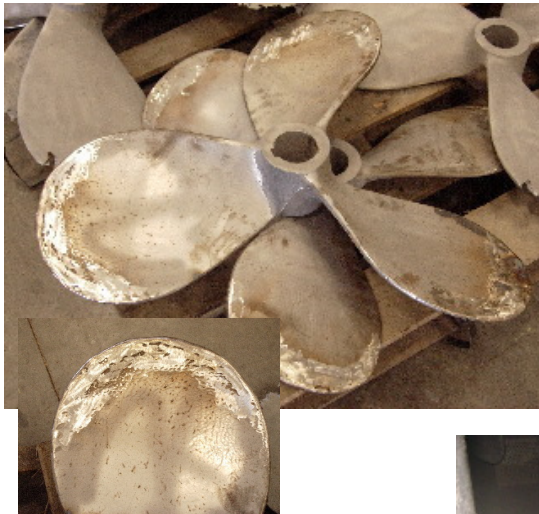
Weld repaired props with 308 stainless steel wire to restore original shape.

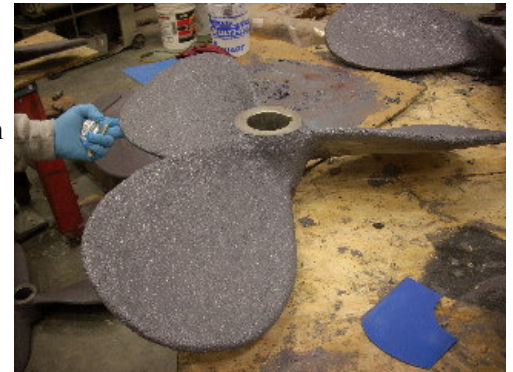
After

Abrasive blasted and coated props with Chesterton BX2 coating.

BX2 is an advanced contractor grade ceramic reinforced composite for repair and protection of metal surfaces. The high concentration of silicon carbide, aluminum oxide and titanium oxide beads provide protection from chemical attack and erosion in extremely abrasive environments. BX2's tough resin structures resist thermal-mechanical shock.

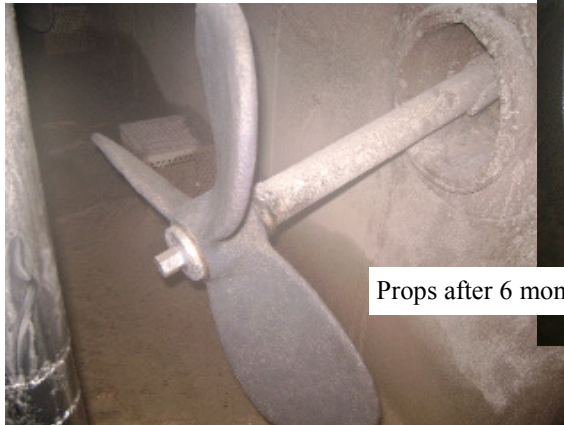
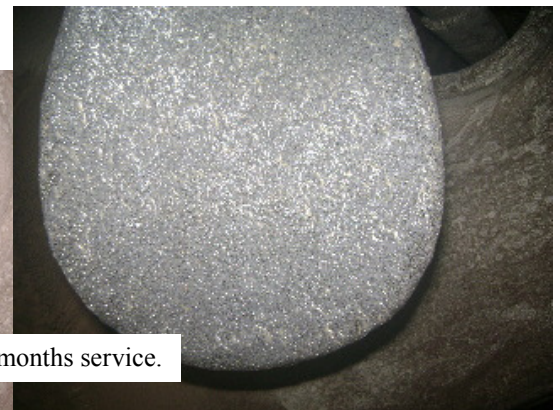
After six months, customer is extremely happy with increased service life and resulting lowered maintenance costs and is continuing a program to coat all props with Chesterton BX2.

Props after 6 months service.
